Cricut Maker Roller fix

After some usage, the Cricut Maker roller has been known to move on the rod causing cut fails.

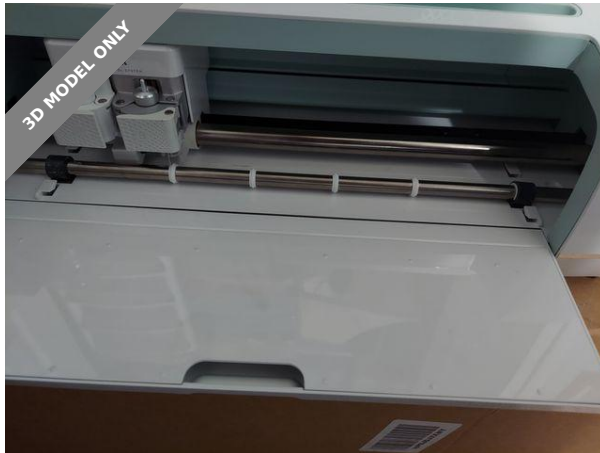
The Cricut Maker has had a problem (on some units) where the roller on the paper hold down bar will migrate off the edge of the cutting mat. This will cause the cut to fail. The details are in the reddit link below. The net of it is that a McMaster - Carr clip was identified as a fix / workaround. While the metal clip is a good solution, I used the McMaster-Carr design file and made it an stl. You can use this to get back in operation while you order a part.

Not much done here except to make the stl available for someone with this issue to get back cutting.
