Casement Window Bearing / Roller repair

The roller on two windows wore out and the arm kept falling out of the track. This fixed it.

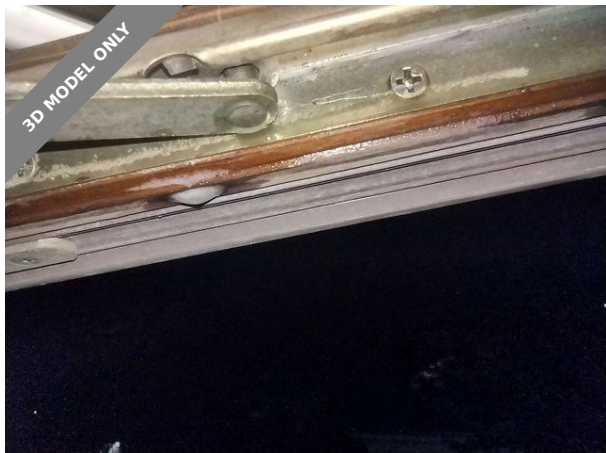
The teflon (or plastic?) roller wheel on the arm wore down - and the arm kept dropping out of the track. The windows are 20 years old and no parts are available. So I cut off the worn plastic and measured the parts. There was a stem on the arm that had a 9x2mm cap with a 6mm post. The track has a groove that's 15x6mm. I designed this to fit snugly in the track. The longer, straight piece is to keep it from dropping out of the opening.

The round portion gets wider as it gets deeper - a 7 degree taper. This holds the cap in place and eliminates the need for supports when printing. I printed it in TPU.

Pop the piece on, rotate to the right direction (my photo of it mounted has the longer part on the wrong side.) This gets forced up into the track. I have a photo of it in place. Spray some WD-40 in the track. Works like new!
