## Mikrotik SFP+ broken hinge fix

Fixes broken release mechanism hinge on Mikrotik SFP+ module

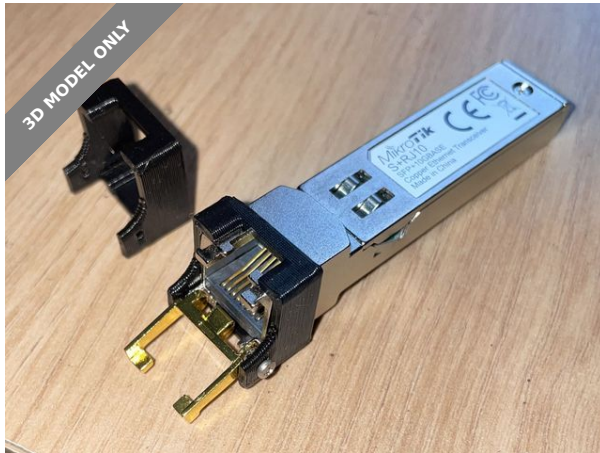
Hinge broke in release mechanism in my SPF+ module. This fixes that

Used M1.6x4.

Note that the fix adds a lot of bulkiness to sides of the module. It might be not possible to place such fixed module in middle between other SFP+ modules in a switch for example.
