Prusa MINI Clog Underextrusion FIX PTFE Cutter

This is a FIX for Prusa MINI clog and under-extrusion based on our tests.

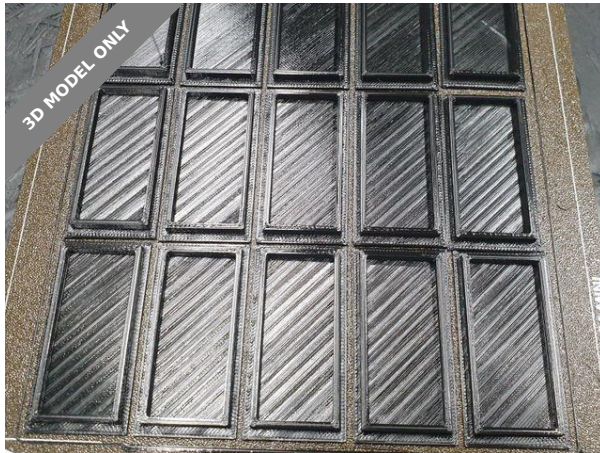
We fixed our underextrusion / extrusion / clog problems on Prusa Mini just cutting the original Hotend PTFE tube to around 40mm and pushing the heatbreak all into the top like this video:

We also add new thermal paste.
