# Armrest Cover Hinge Repair for VW

This is a hinge repair designed for the center console armrest for a VW Golf, though it should work for other VW models.

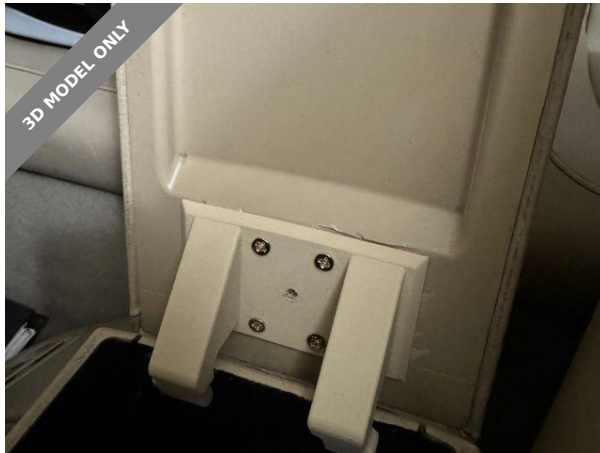
This was designed to repair the broken hinges on the center console arm rest cover of a Volkswagen Golf, but if my research is correct, I think it will work on several Volkswagen models including many Volkswagen Golf, Jetta, Beetle, Bora, Passat, Lupo, and Skoda Octavia.

Your best bet is to look at the included picture to see if your hinges look the same.

If so, the repair involves cutting off whatever remains of the factory “arms” using a rotary tool, and gluing (I recommend JB Weld) and/or screwing this plate in place. It should be centered, and the edge should line up with the rectangular indent on the inside of the cover.

This should be printed in a heat tolerant material as PLA will not last in a hot car. I printed this at a 0.2 layer height WITH supports out of black PETG.
