Leica CL take up spool

the often broken take up spool from the leica cl

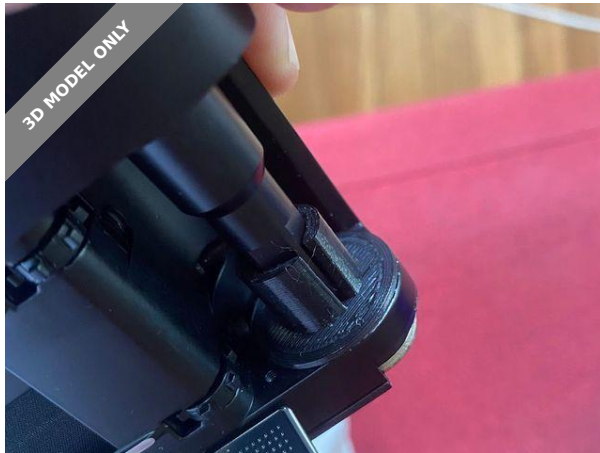
Plastic take up spool broke on my CL, I designed a new one to print and replace it with. I printed in PETG and it seems to work great.
