## 08 Dodge Caravan HVAC blender door actuator gear

### Summary

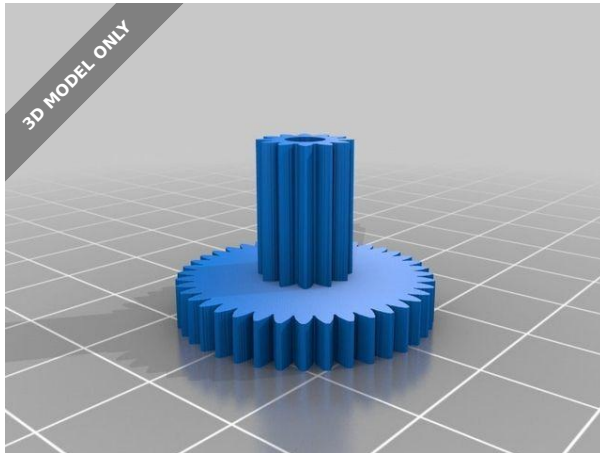
This is a common failure for Dodge vehicles. Mine made a clicking noise when changing from hot to cold and got stuck on hot only, then continued making a clicking noise for ~10 minutes, sometimes even with the engine off and key removed. Not fun on a 3 hour road trip. This was on the drivers side. Grease the gear before reinstalling. Remember to calibrate the actuator when reinstalling or it may strip again. Should also work for other models with the same actuator, Dodge Ram, Avenger, Caravan, Town & Country, etc.

After printing use a drill to clear the center bore, bit size 11/64". use a small triangle file to clean up the teeth a little if necessary. I only had to run the file through the larger diameter gear teeth very lightly to square them up.
