CCTREE spool fix for Bambu AMS

Clip to close the notches in CCTREE spools

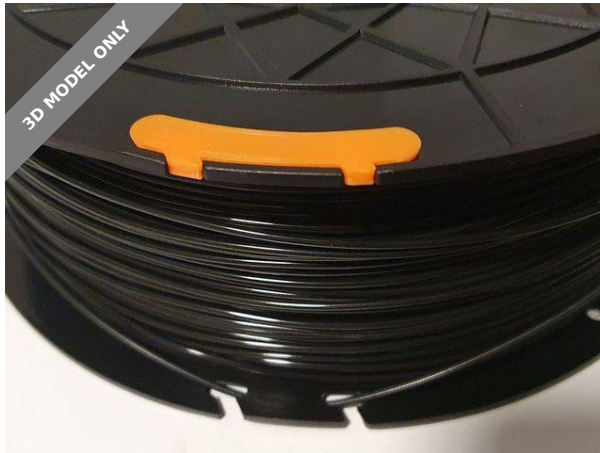
The CCTREE spools I have, have notches in them. These notches catch on the Bambu AMS feeder rollers, causing feed errors. At worst, I believe this could lead to damage to the AMS. So, these clip in place clips are designed to fill the notches, ensuring a smooth roll off the spool over the feeder rollers in the Bambu AMS.
