Replacement for Mansfield Toilet model 48 Chrome Push Button Trip Lever

Replacement for Mansfield toilet model 48 chrome push button trip lever

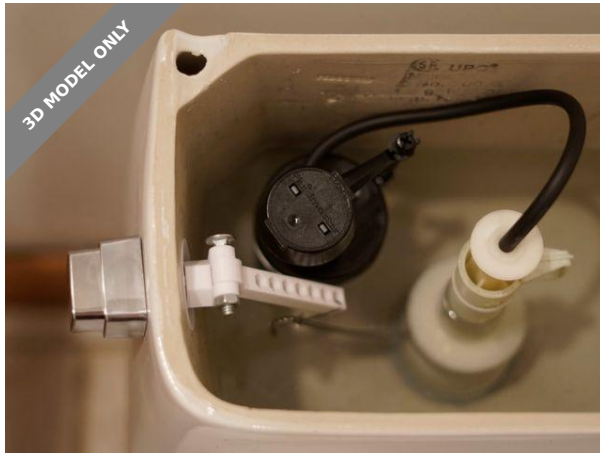
The photos work backward from the completed repair...

Here's my solution. Buy the Rrina chromed-plastic button and 3D-print custom mounting and trip lever parts. I strongly suspect similar-looking kits have compatible chromed parts. Then 3D print, using PLA or your favorite material, the following simple parts: locking nut, washer, holder, and thrower arm. You'll also need a 1/4-20 bolt and nut. To assemble:

1. Remove the original button assembly. If yours is like mine, all the metal parts are badly corroded and this step will be challenging. NOTE THAT THE THREAD IS REVERSED, SO IT IS TURNED RIGHT (CLOCKWISE) TO LOOSEN. This reversed thread seems to be standard for the buttons, as both the original and replacement part have it. After much pain, I found that a few squirts of Free All Deep Penetrating Oil Rust Remover on the parts inside the tank worked like magic to free it up to a level where a socket wrench could do the work. If you're not so lucky, the original is a huge pain to remove because it is made of very solid metal and you can't get enough access to the shaft to easily cut it with a saw.

2. Put the new chromed button in from the tank outside and secure it against the inside of the tank's outer wall using the locking nut. A 13/16" socket can be used to tighten the printed locking nut but DO NOT OVERTIGHTEN. It should be just tight enough that the button will not easily spin on the outside of the tank.

3. Assemble the holder and thrower arm using the 1/4-20 bolt and nut. You don't need to make it too tight; the bolt is simply used as a low-friction pivot for the arm.

4. Put the washer on the threaded part of the chromed button inside the tank. There wasn't any washer in the original version, but this oversize washer covers the larger hole in the inner tank wall, which makes things a bit neater as well as providing some flex tensioning for the next part.

5. Screw the holder and thrower arm assembly on after the washer. Tighten it only enough to stay in position with the pivot and bolt on top.
6. Adjust and connect the pull chain to one of the holes in the thrower arm. I used the last hole, but you have options.
