Omnibot 5402 Arm Linkages

Replacement arm linkages for the Tomy Omnibot model 5402 from the 1980s.

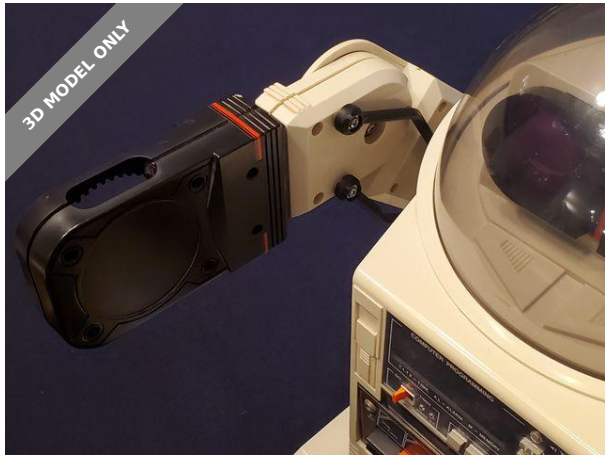
Each arm has two linkages. The lower linkage has a gap cut into it in order to allow the arm to fully retract without colliding with the upper linkage. Special attention needs to be paid to which way you install these as the inner dimensions of the attach points are different. The more rounded side of the attach point should be toward the torso, while the flatter side should be outward. If there is enough interest, I may try to add the greebles from the original linkage.

I printed mine in PETG, as this material will flex more than PLA before breaking.

Recommended settings:

Wall Loops: 6

Supports: Enabled
